Inspection Report for

**P-67-781**

**Village Hall Dr over Underwood Creek**

Oct 8, 2025

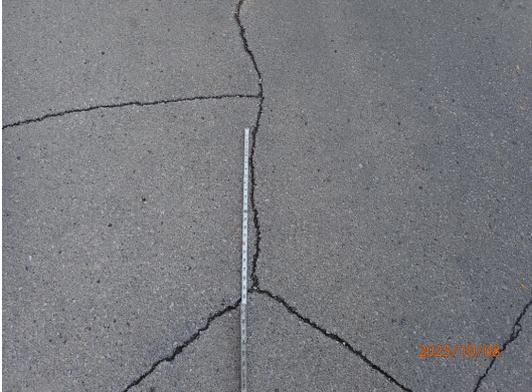
Item	Priority	Recommended by	Status	Status change
<b>IMP-Polymer Modified Overlay</b>	Medium	Roesch, Matthew (9725)	DEFERRED	10/28/24
<p>Comment: Replace asphalt overlay to prevent further seepage through to superstructure.</p> <p>Status Comment:</p>

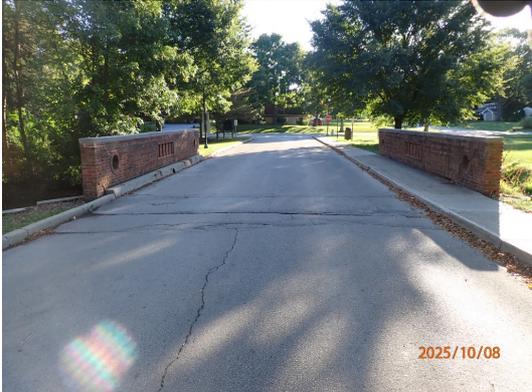
<b>Approach - Seal Approach to Paving Block</b>	Medium	Roesch, Matthew (9725)	DEFERRED	10/28/24
<p>Comment: Seal approach joints to prevent abutment water seepage.</p> <p>Status Comment:</p>

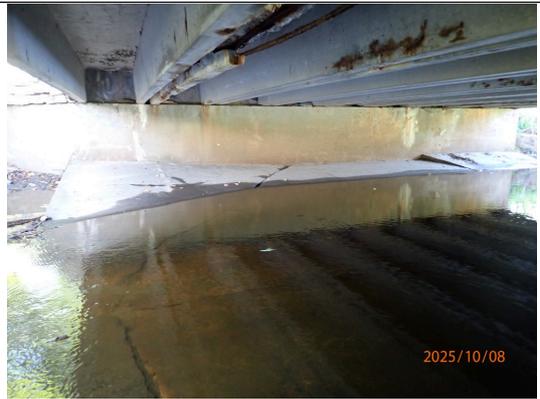
**Routine Item 8**

View of east abutment/deteriorated concrete lining, looking east.

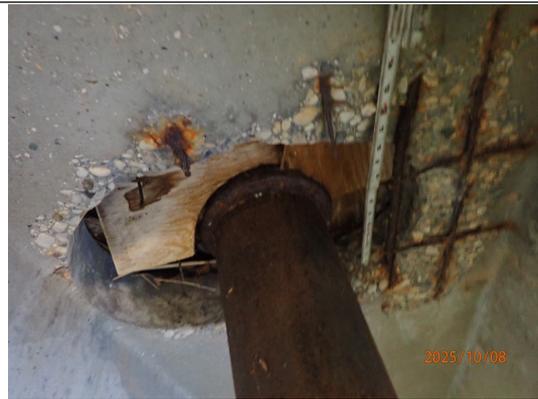
**Routine Item 10**

View of spall near south deck drain, looking east.

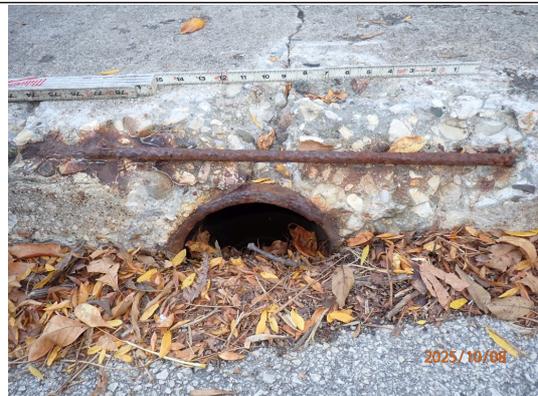
**Routine Item 11**

View of spall in south sidewalk, looking north.

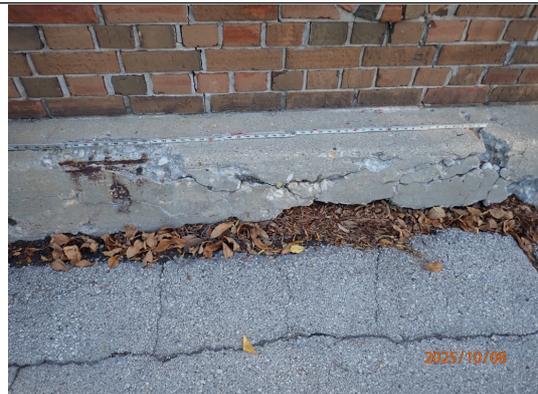
**Routine Item 12**

X	334	Masonry Bridge Rail	LF	64	13	1	50	0	
		Delamination - Spall - Patched Area	LF		0	0	0	0	
		<b>50% of the north curb length exhibited rust staining and delamination. (16 LF CS3, overlapping)</b>							
	1080	Mortar Breakdown (Masonry)	LF		0	0	50	0	
		<b>The masonry ledge angles on the exterior faces of the bridge exhibited heavy corrosion with up to 10% loss of section. (6 LF CS3)</b>							
		<b>12.0' L area of the south angle was missing. (12 LF CS3)</b>							
	1610	<b>12.0' of bricks were missing, mostly at the sidewalk interface. (12 LF CS3)</b>							
		<b>The mortar exhibited random cracking with moderate to heavy deterioration with loose masonry. (10 LF CS3)</b>							
		<b>10.0' of deterioration in the top cap, with loose caps. (10 LF CS3)</b>							
	1640	Masonry or Panel Displacement	LF		0	1	0	0	
		<b>The south parapet was 2" out of plumb to the north. (1 LF CS2)</b>							
			EA	4	0	3	1	0

View of spalling and delamination in the east end of the north curb, looking north.

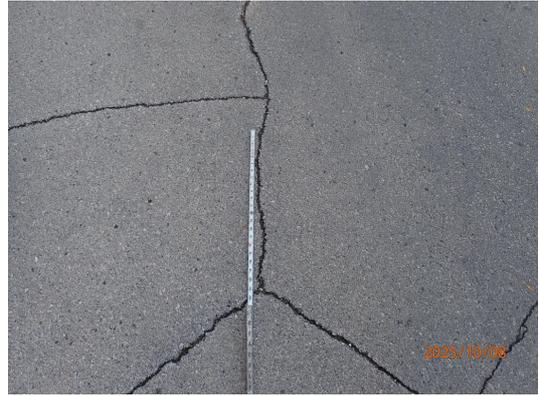
**Routine Item 13**

8511	HMA (AC) Overlay	SF	693	618	20	55	0
3220	Crack (Wearing Surface)	SF		0	20	55	0		
	<b>Some moderate to wide</b> longitudinal and transverse cracking. <b>(20 SF CS2, 55 SF CS3)</b>								
X	109		<b>Prestressed Concrete Open Girder</b> Girders are numbered N to S.	LF	247	124	49	57	17
		1080	Delamination - Spall - Patched Area	LF		0	34	39	17
			The girder <b>ends</b> exhibited rust staining, delamination, and <b>6" L</b> by up to 1" D spalls <b>at abutments. (18 LF CS3)</b> <b>Random areas of</b> exposed reinforcement <b>on all girders on up to 5% of the surface area. (13 LF CS3)</b> <b>Girder 1: Patched spall. (2 LF CS2)</b> <b>Girder 2: 20.0' L by 7" H by 3" D spall with multiple exposed reinforcements</b> with up to <b>50%</b> loss of section <b>in the north end. (8 LF CS3, 12 LF CS4); 3.0' L delamination with rust staining in the south end. (3 LF CS2, 1 LF Overlap)</b> <b>Girder 6: 15.0' L delamination</b> in the south web. <b>(15 LF CS2)</b> <b>Girder 7: 15.0' L delamination</b> in the bottom of the south web. <b>(15 LF CS2)</b> <b>Girder 9: 5.0' L by 5" H by 3" D spalls</b> with exposed corroded strands with up to 20% loss of section. <b>(5 LF CS4)</b>

View of wide cracking in overlay, looking east.

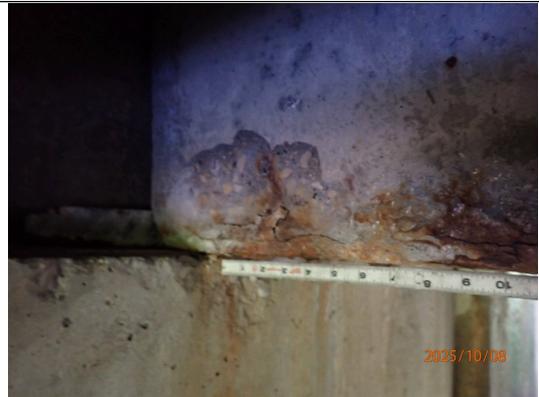
**Routine Item 14**

View of typical girder end deterioration, looking west.

<p>Comment: Remove delaminations and repair spalls with concrete patching.</p> <p>Status Comment:</p>				
<b>Misc - Other Work</b>	Medium	Roesch, Matthew (9725)	IDENTIFIED	01/22/26
<p>Comment: Install object markers (4 EA)</p> <p>Status Comment:</p>				
<b>Misc - Other Work</b>	Medium	Roesch, Matthew (9725)	IDENTIFIED	01/22/26
<p>Comment: Replace Structure</p> <p>Status Comment:</p>

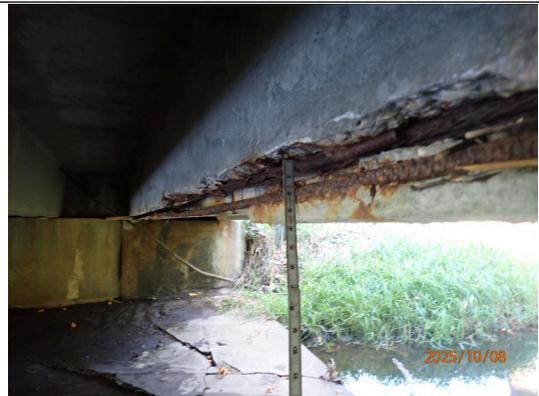
**Routine Item 15**

1110	Cracking (PSC)	LF		0	15	18	0		
	<b>Girder 2 exhibited wide cracking in the north end. (5 LF CS3, Overlap)</b> <b>Girder 4 exhibited a 3.0' L area of cracking with rust staining at midspan. (3 LF CS3)</b> <b>Girder 8 exhibited a 15.0' L moderate crack in the bottom</b> of the south web. <b>(15 LF CS2)</b> <b>Girder 8 exhibited cracking with efflorescence and stalagmite in the north web on the east half. (15 LF CS3)</b> <b>Girder 9 exhibited a moderate vertical crack at midspan. (1 LF CS2, Overlap)</b>								
X	215		<b>Reinforced Concrete Abutment</b> <b>Water seepage evident from backwall above. Heavy efflorescence on face at beam joints.</b>	LF	87	62	23	2	0
		1080	Delamination - Spall - Patched Area	LF		0	8	2	0
			West ends exhibited spalling/delamination below girder ends. <b>(8 LF CS2)</b> 10" diameter by 6" D spall at southwest drain at south end of west abutment. <b>(1 LF CS3)</b> The west abutment exhibited a 6" W by 6" H by 1" D spall under girder 6. <b>(1 LF CS3)</b>

View of spall in Girder 2, looking west.

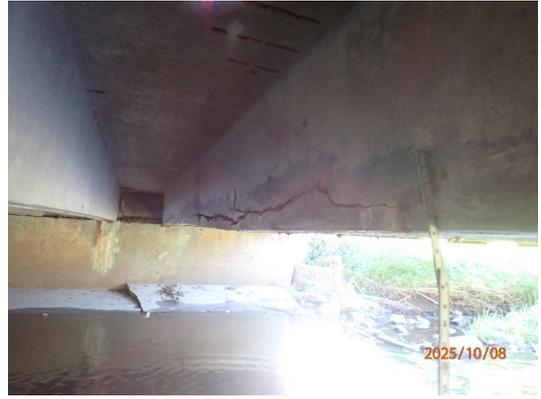
**Routine Item 16**

View of delamination in Girder 7, looking east.

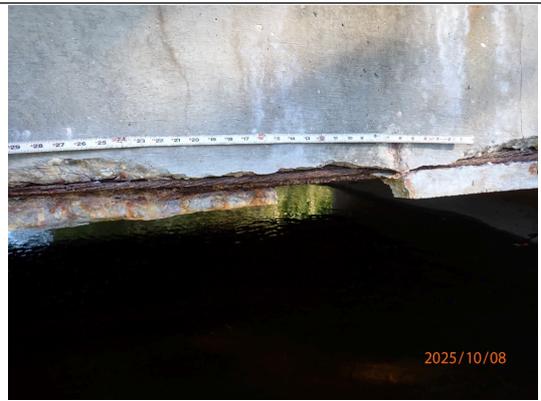
**Routine Item 17**

View of spall in Girder 9, looking north.

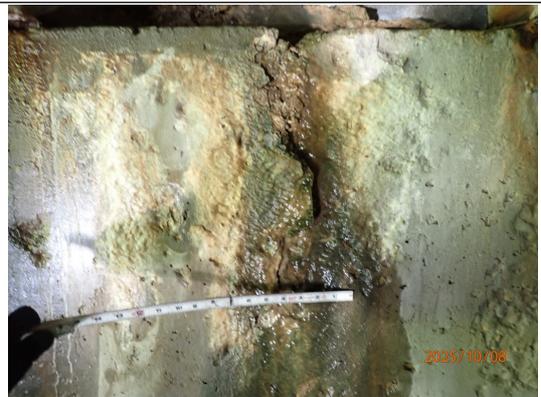
**Routine Item 18**

View of spall in west abutment under Girder 6, looking west.

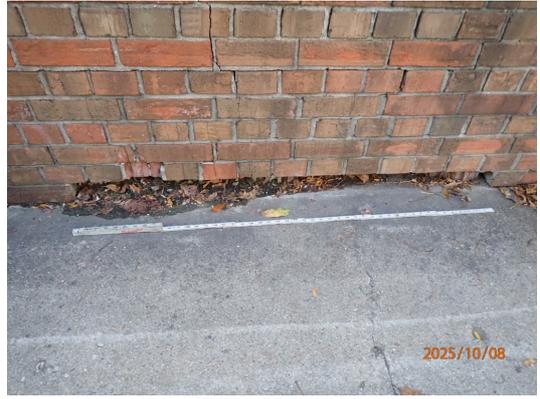
**Routine Item 19**

View of typical masonry deterioration, looking south.

<b>Misc - Other Work</b>	Low	Roesch, Matthew (9725)	IDENTIFIED	01/22/26
Comment: Repoint masonry and prevent masonry bridge rail movement.		Status Comment:

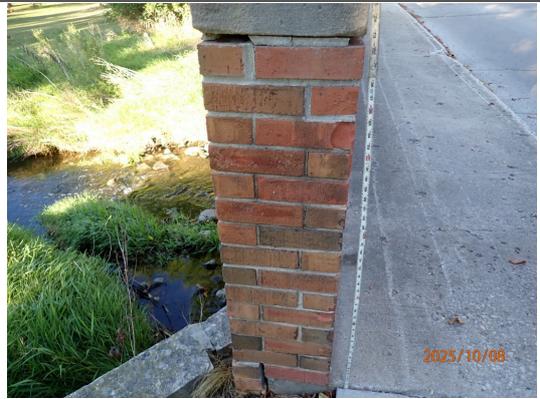
**Routine Item 20**

View of out of plumb south rail, looking west.

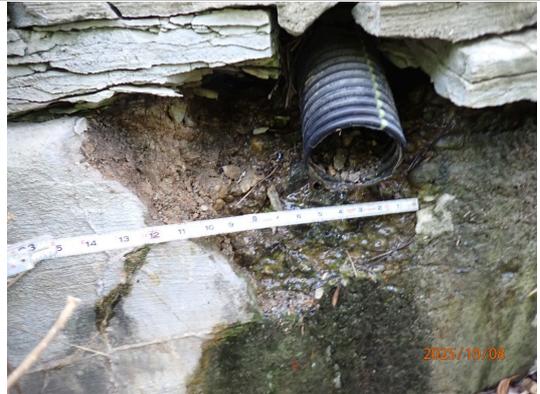
**Routine Item 21**

X	8400	Integral Wingwall	EA	4	0	3	1	0	
		Wall Deterioration	EA		0	3	1	0	
		<b>The wingwalls exhibited random insignificant map cracking with efflorescence at the abutment/wingwall interface. (4 EA CS2)</b>							
	8903	<b>The northwest wingwall exhibited a 6" diameter by 8" D spall below drain. (1 EA CS3)</b>

View of spall in northwest wingwall, looking west.

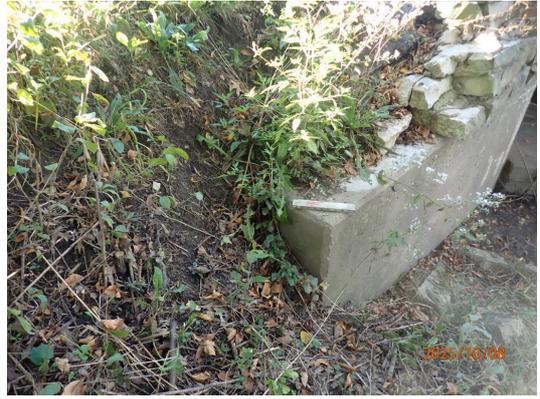
**Routine Item 22**

Chk	Element	Defect	Description	UOM	Total	Quantity in Condition State			
						1	2	3	4
X	9001		<b>Drainage - Ends of Structure</b>	EA	4	4	0	0	0
X	9041		<b>Slope Protection- Bare</b> The embankment exhibited erosion behind all 4 wingwalls, causing the masonry portion of the north wingwalls to deteriorate and fail.	EA	4	0	2	2	0
X	9042		<b>Slope Protection- Concrete</b> Concrete lined channel under bridge has moderate deterioration and the slope has settled. Portions may be missing.	EA	1	0	0	1	0
X	9323		<b>Approach Roadway - Asphalt</b> The west approach exhibited transverse cracking. New wedges noted in 2016.	EA	2	1	1	0	0

View of typical erosion behind wingwalls, looking south.
